## **Case Study**

**Grästorp Fjärrvärme AB** - **Grästorp District Heating Plant** Co-owned by Lantmännen Agroenergi AB and the municipality of Grästorp, Sweden.

## Service carried out on all valves after 4 years in operation.

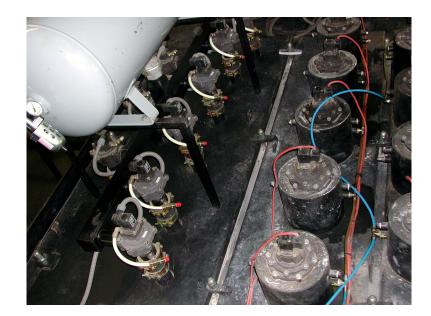
Fuel: Wood chips and Salix

Boiler: 3.5 MW – installed 2002

Soot-blower: The boiler was delivered with a soot-blowing system at the top of the boiler 9 pcs. valves on 1<sup>st</sup> stroke countercurrent 5 pcs. valves on 2<sup>nd</sup> stroke wake 7 pcs. valves on 3<sup>rd</sup> stroke countercurrent

Efficiency: Mechanical cleaning was necessary several times per month – the pipes were not kept clean.

Initiative: It was decided to replace the soot-blowing system on the 1<sup>st</sup> stroke. AEROVIT soot-blowers on a new boiler door were delivered February 2003.

Result: Mechanical cleaning only necessary twice a year. The pipes in 1<sup>st</sup> stroke are now kept clean. The pipes in 2<sup>nd</sup> stroke are now kept fairly clean. The pipes in 3<sup>rd</sup> stroke are not kept clean.

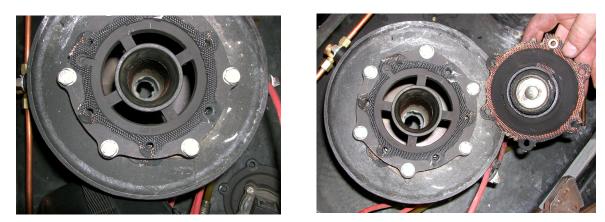
The soot-blowing system – without cooling – on  $2^{nd}$  and  $3^{rd}$  stroke shows dysfunction and flow of compressed air.

All 12 valve diaphragms were burned or melted, cracked and rigid – clearly affected by the heat from the boiler's turn box. All diaphragms had to be replaced.

Corrosion in the shot tube of the valves – obviously affected by corrosive flue gas.

The shot tube is almost sooted up in consequence of dysfunction.

AEROVIT's valve system – with cooling – on 1<sup>st</sup> stroke has faultless function.

All 9 valves and valve diaphragm are in good condition and require no replacement. Clear result of AEROVIT's patented system with cooling air.
