Vessel: **M.V. SPLIT**

Boiler: **TPK Nova, flame tube**

Problems: Large deposits of soot have been formed inside the flame tubes requiring frequent stoppage of the boiler for cleaning, causing time loss and increased fuel consumption.

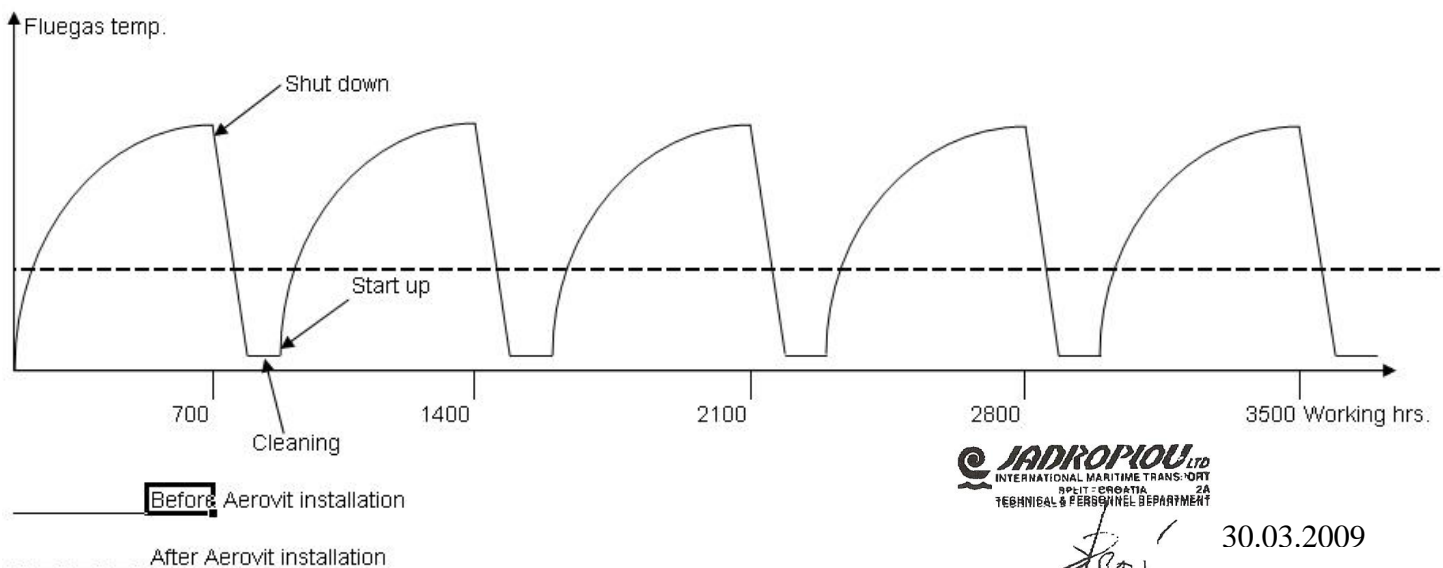
After 700 hours of operation, with **AEROVIT** installed, the boiler was opened for internal tube control. All tubes were clean and passable as if they were new.

After installation of **AEROVIT** in April 2008 the boiler has been working more than 6000 hours and has not been stopped for manual cleaning.
