CASE STUDY

16-Month Payback and Up to 90% Fewer Cleanings: How E.ON Sweden Boosted Efficiency with Aerovit

E.ON, Sweden

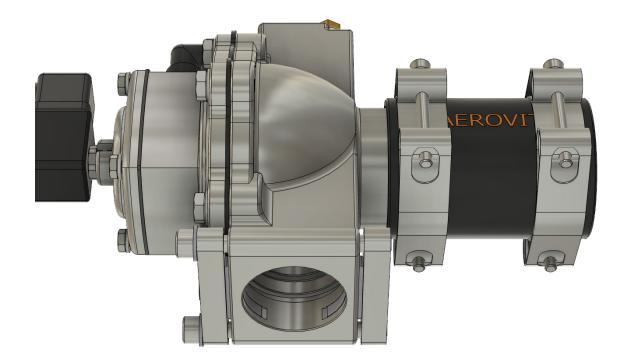
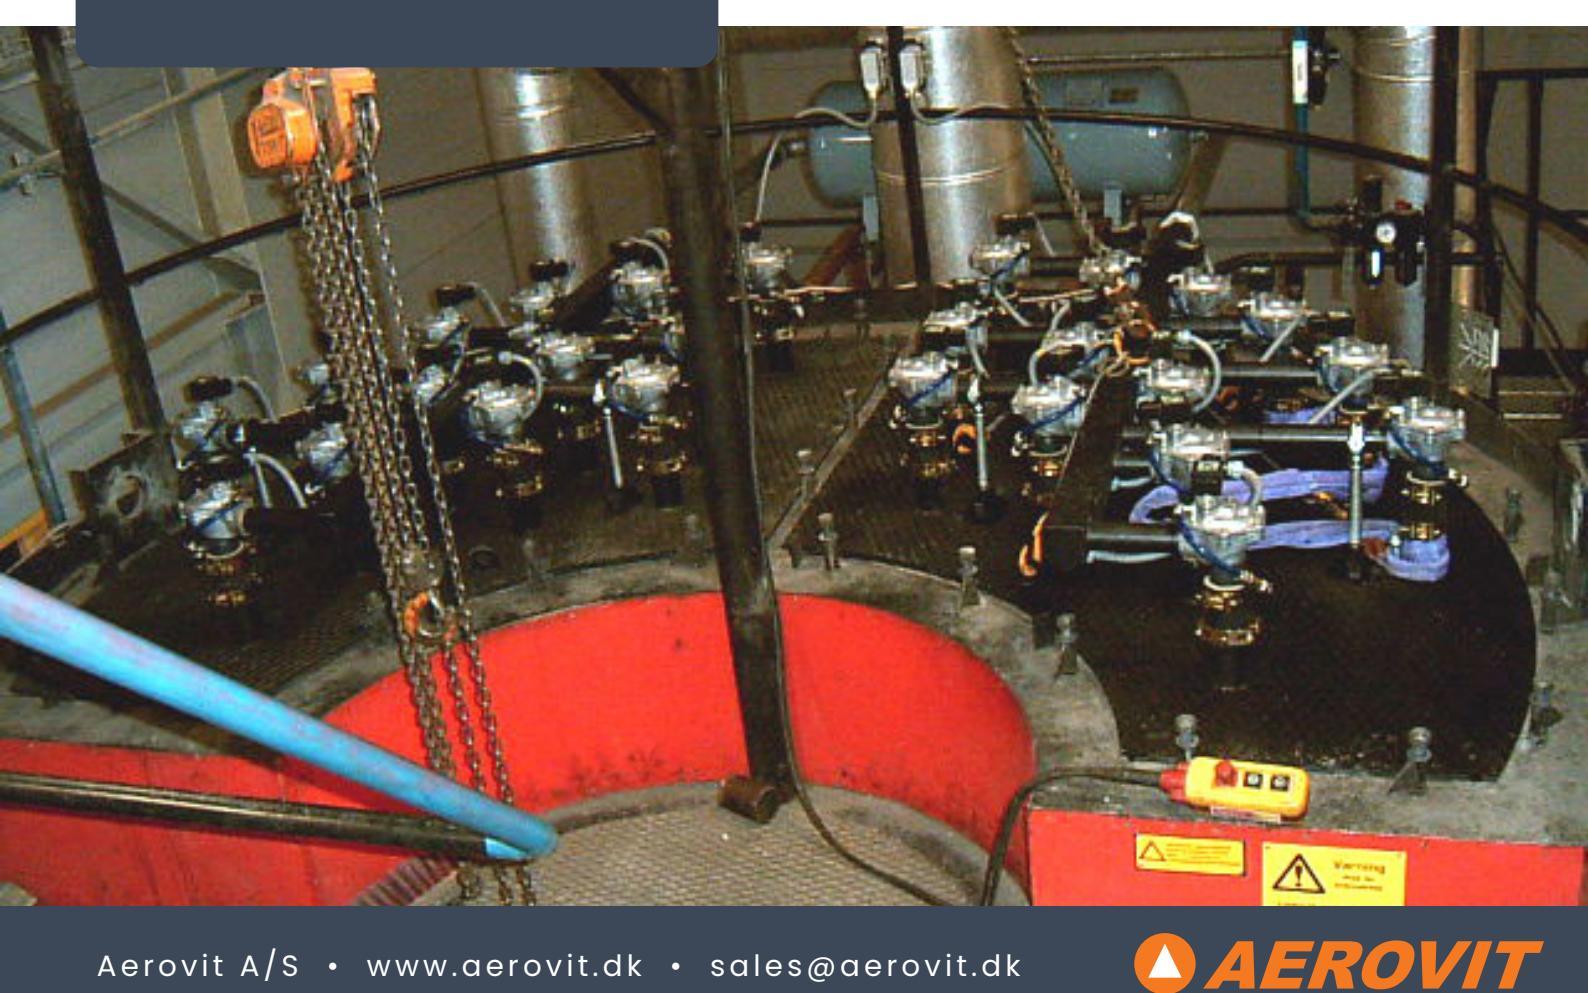
At each plant, the Aerovit system was mounted directly onto the boiler.

It works by sending short, powerful bursts of compressed air into the boiler to prevent soot and ash from settling on heat transfer surfaces. As a result, flue gas temperatures remain more stable, the boilers operate closer to optimal conditions, and the need for manual cleaning is drastically reduced. For example:
